**May 31, 2024**

**Technical Service Bulletin – 01**

Mustang Dark Horse R Rear Dampers

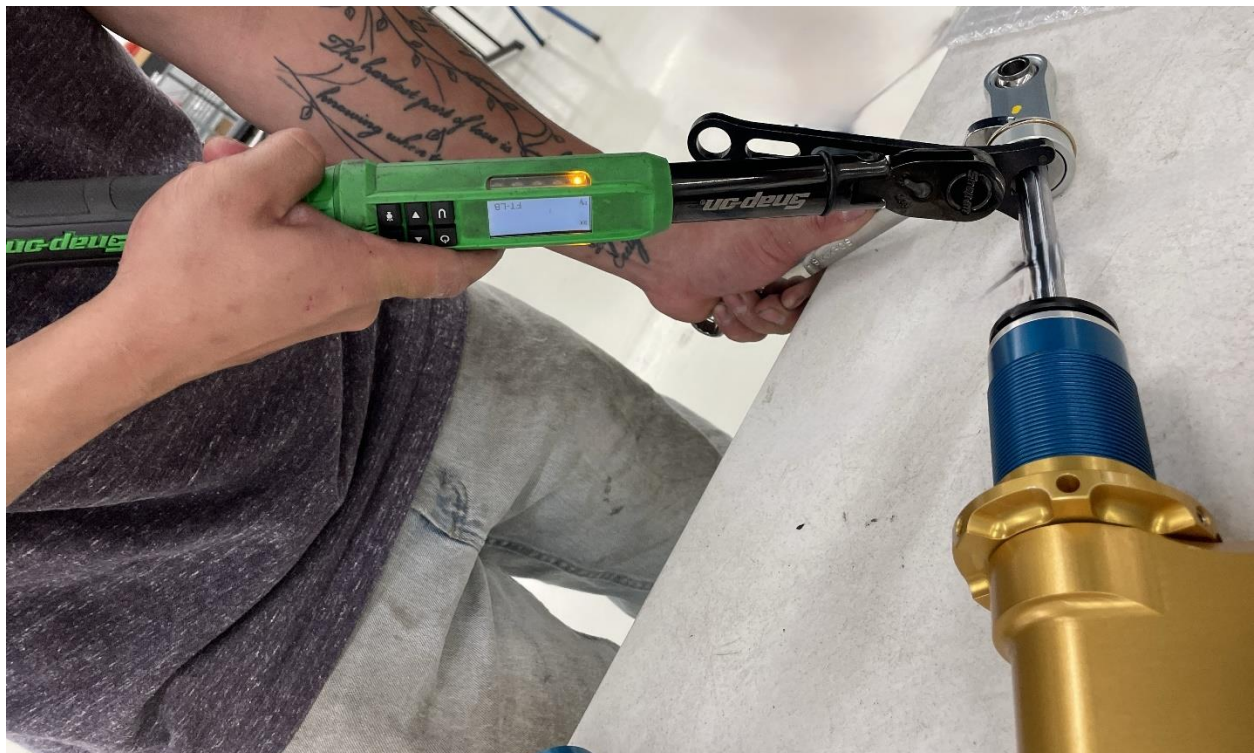
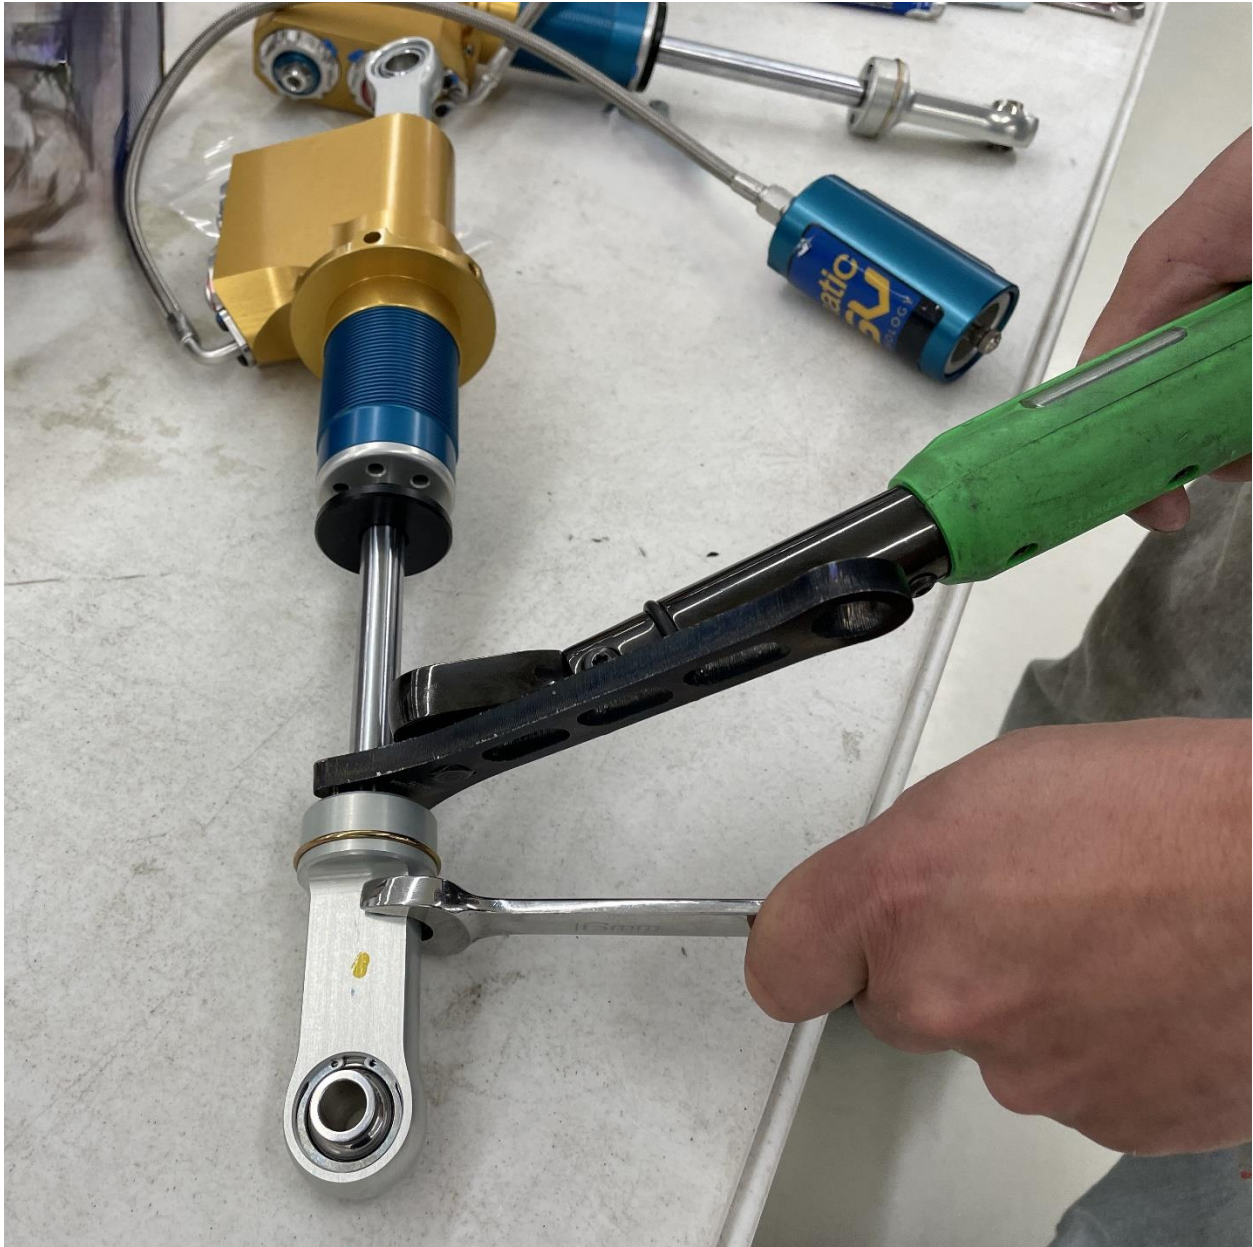
Issue: Rear Dampers – the shaft end eye and nut are not properly tightened as delivered.

Action: Follow the procedure to tighten the shaft end eye.

- Fully seat nut on shock shaft
- Apply 2-3 drops of Loctite 243 to shaft end eye threads
- Hold eye with an appropriate tool, and tighten nut to 20 ft-lbs

Special holding tools for the nut, similar to tool shown below, will be supplied for vehicle owners at the Mid-Ohio race event.
