August 23rd, 2024

Technical Service Bulletin – 15

Exhaust Heat Wrap

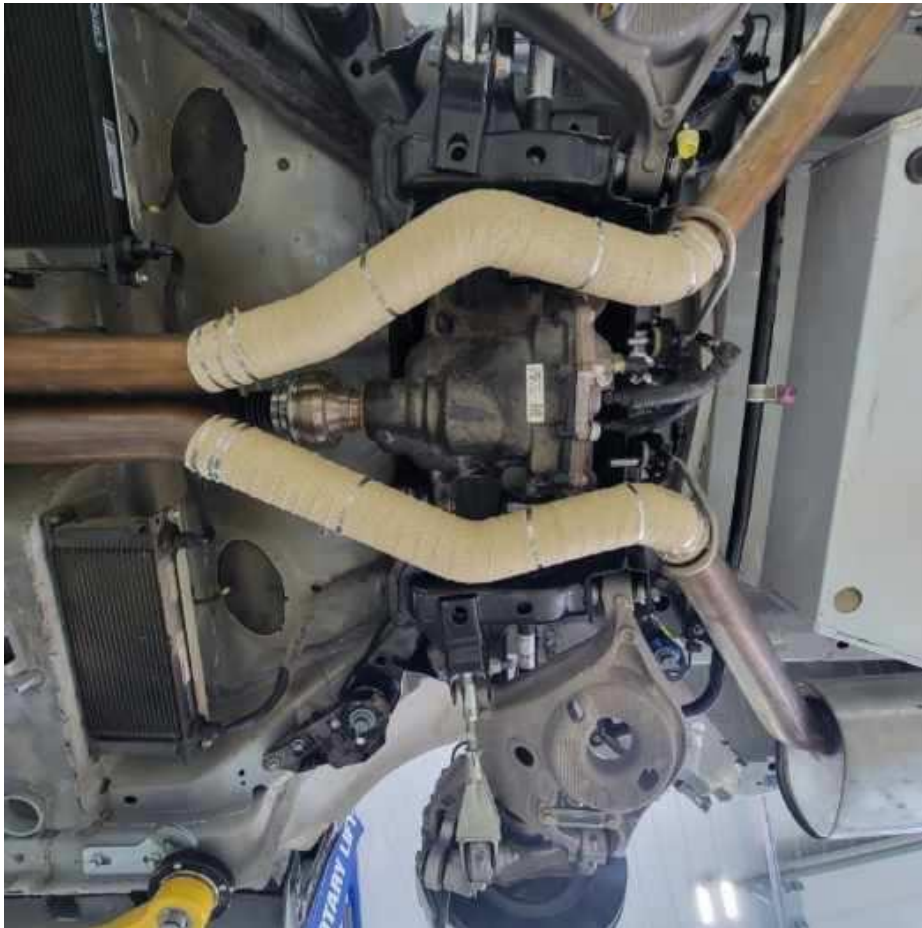
Issue: Excessive exhaust heat can cause degradation of the half shaft boots and grease.

1. Install wrap as shown from the exhaust bend closest to the differential coolers up to the exhaust hangers located just behind the differential.
2. Use approximately a 50% overlap of the wrap.
3. Use band clamps on both ends. Additional clamps may be used as desired.

Note: Please inspect half shafts for signs of temperature related degradation and replace as necessary.
