Technical Service Bulletin – 03

Mustang Dark Horse R Engine Cooling - Ducting

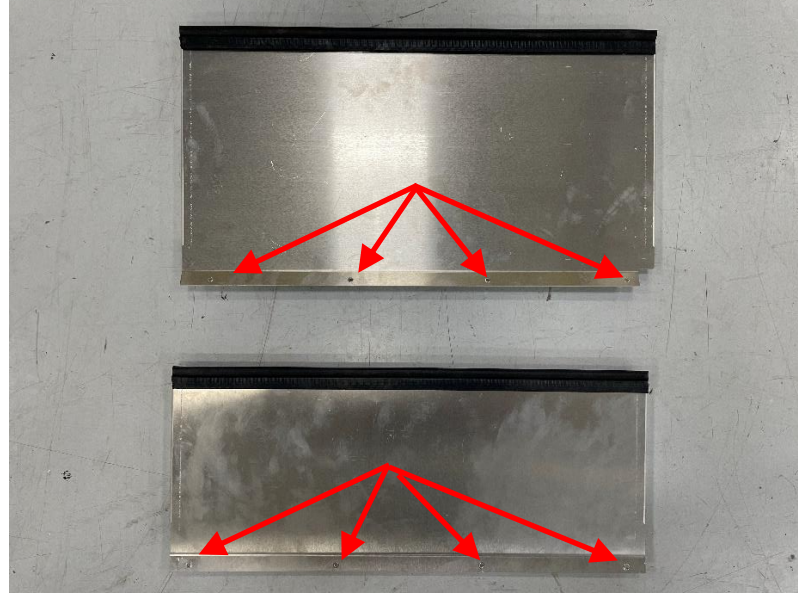
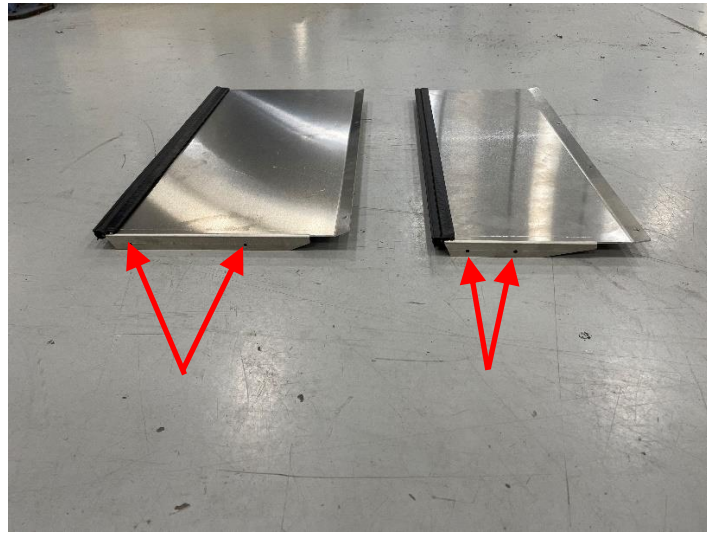
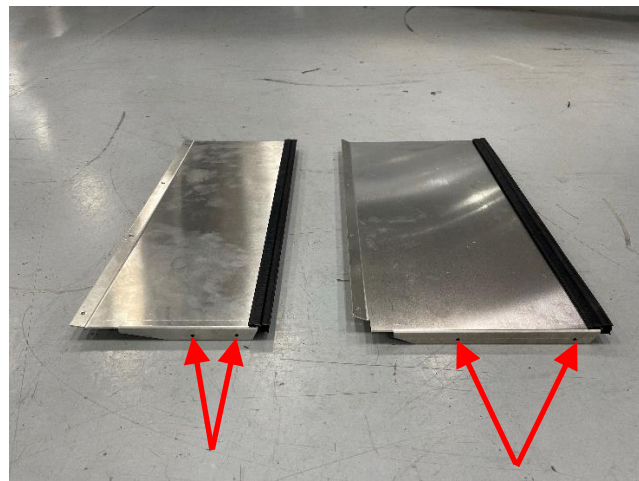
Issue: Some Mustang Dark Horse R's have experienced high engine coolant temperatures on track.

- Remove the front fascia
- Drill out the rivets on the ducts
 - Upper Duct
 - Remove the 4 rivets on the long side near the front
 - Remove the 2 rivets on both the right and left hand sides
 - Remove the upper duct
 - Lower Duct
 - Remove the 4 rivets on the long side near the front
 - Remove the 2 rivets on both the right and left hand sides
 - Remove the lower duct

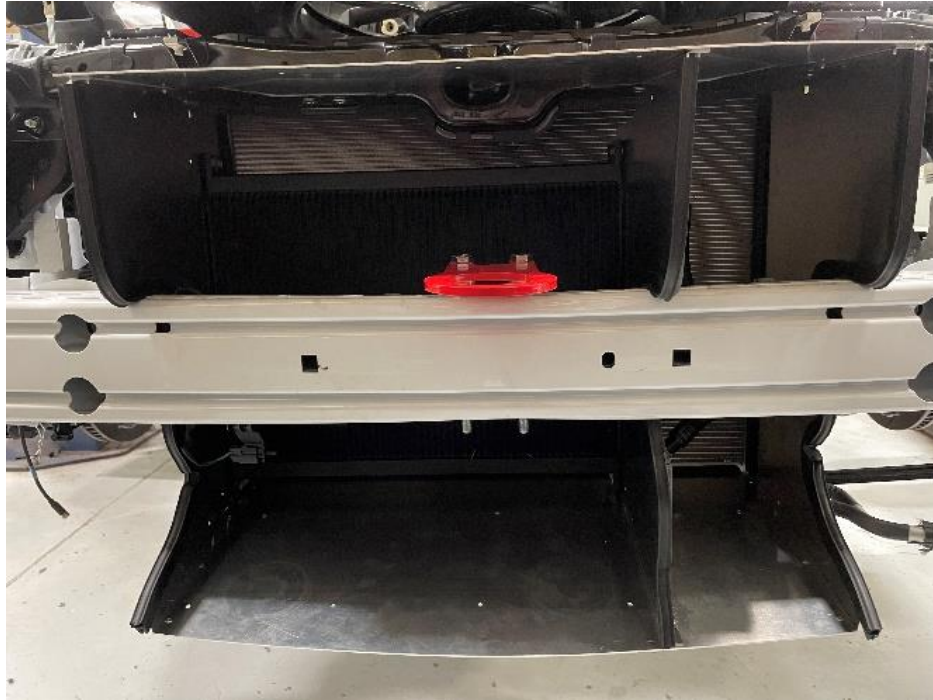
Finished ducting will appear as below
